## **COMPOSITION AND CHARACTERISTICS OF BRICK FOR CONSERVATION AND RESTORATION MATERIALS OF HERITAGE BUILDINGS AS AN INSPIRATION FOR SUSTAINABLE CONSTRUCTION**

### **Abstract**

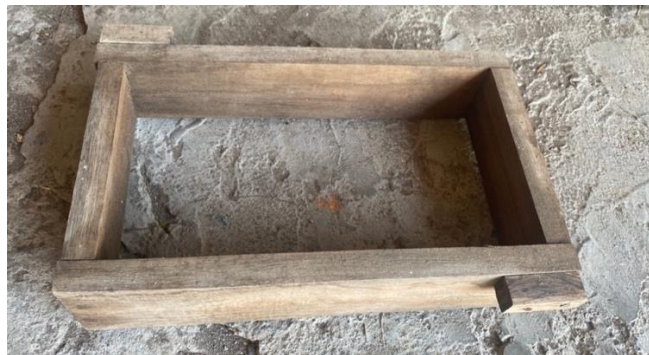
- 1) Make a wooden mold measuring 5.5 x 14 x 25.5 cm.

**Figure 1:** *Wooden mold measuring 5.5 x 14 x 25.5 cm*

- 2) The size of the wooden brick mold can be adjusted according to needs.
- 3) Pouring the processed clay into the wooden mold.
- d. Drying the Material

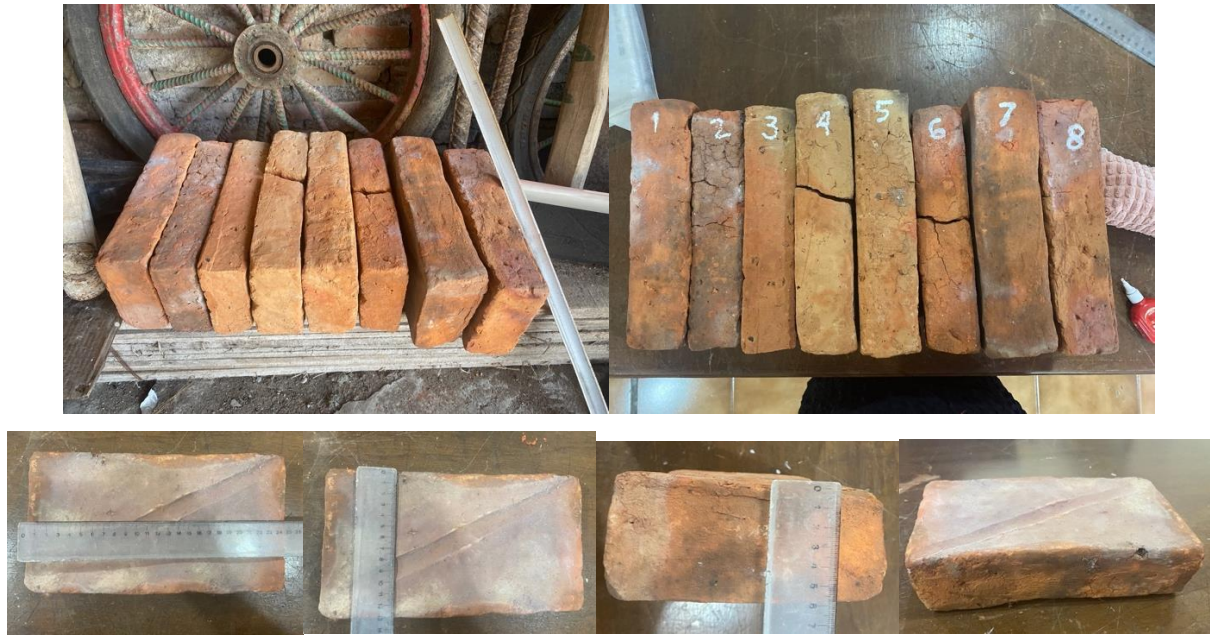
**Figure 2:** *Repair bricks Production Results*

- 7) Jaten District, Karanganyar Regency
    - 8) Kedunggalar District, Ngawi Regency
  - b. Results of bricks from different locations/regions

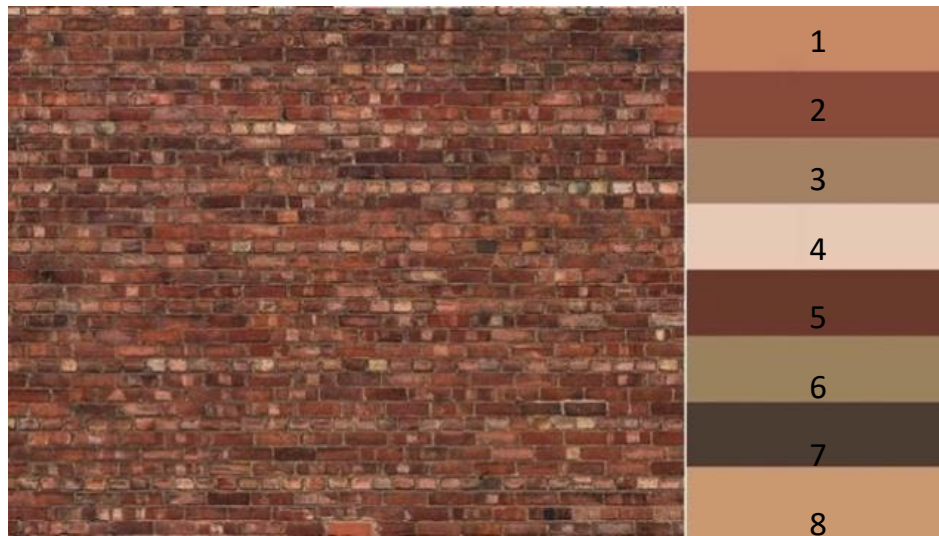
**Figure 3:** *Color numbering on bricks material*

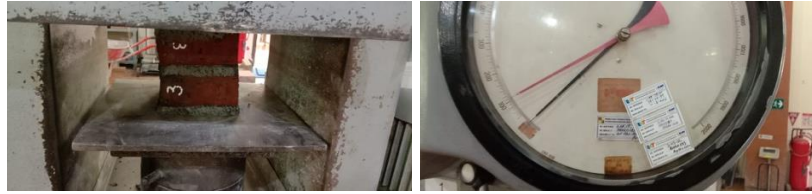
**Figure 6:** *Compressive Strength Test Sample*

The characteristics of heritage bricks in 10 samples were determined using mechanical properties tests, including the results of tests conducted in the Civil Engineering Laboratory, including Apparent Density Test, Water Absorption Test, and Compressive Strength Test (ASTM E447-97.1997). The results of the heritage brick's mechanical properties were taken from three samples at each location, as shown in Tables 3, 4, and 5. According to SNI 15-2094-2000, the procedure for testing the compressive strength of solid bricks is as follows: after molding, the test specimens are removed the next day. They are then soaked in clean water (room temperature) for 24 hours (one day). They are then removed and their surfaces wiped with a damp cloth to remove excess water. The specimens are then compressed until they break, with a compression rate set to 2 kg/cm<sup>2</sup>/second. The compressive strength value is obtained by dividing the highest compressive load by the smallest compressive area. The average compressive strength is obtained by dividing the sum of the compressive strengths of all specimens by the number of specimens. According to SNI 15-2094-2000 the water absorption test procedure is: The test sample is soaked in water until saturated, then weighed (A). Dried at a temperature of (100-110)°C for 24 hours, after which it is cooled to room temperature and then weighed (B). Finally, it is calculated using the formula  $(A-B) / B \times 100\%$ , so that the water absorption value is obtained. Test documentation is in figures 4 to 6.
